Annual Progress Report of the *Massachusetts Division of Marine Fisheries* Eelgrass Restoration Project

**Period Covered:
July 1, 2005-June 30, 2006**

FY-06 Activities Update - Alison Leschen, Ross Kessler, and Bruce Estrella

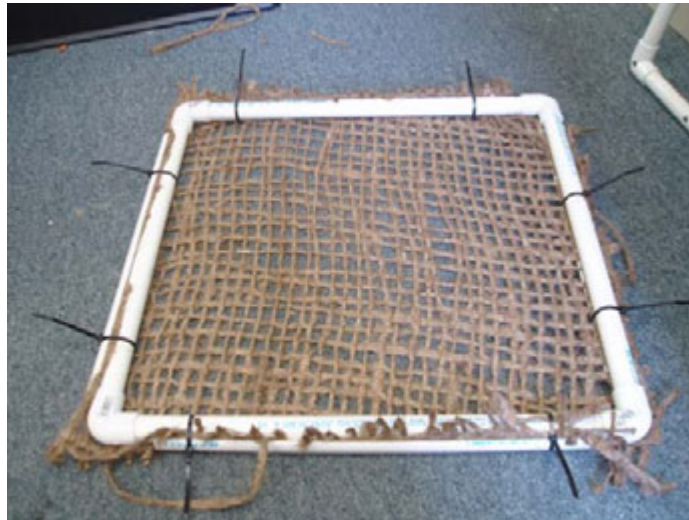
Figure 3. A PVC frame/jute mesh structure (string frame) was constructed as a lighter-weight alternative to TERFs™.

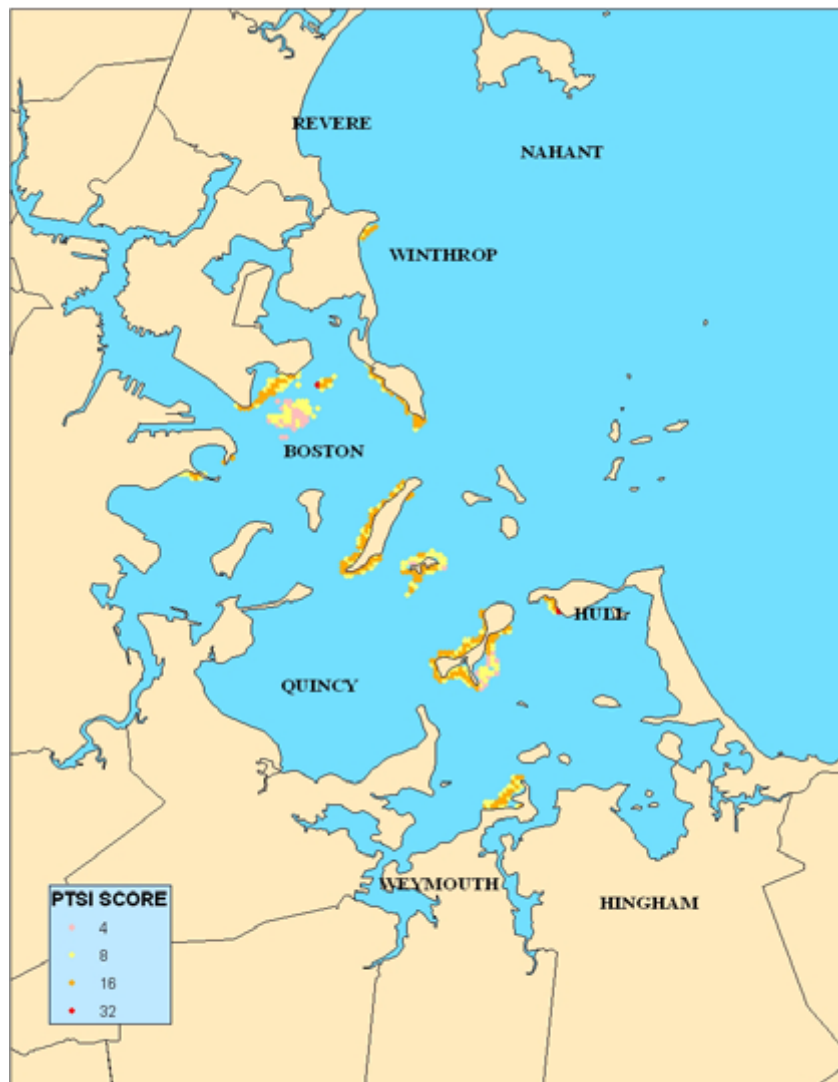
Figure 4. PTSI (Preliminary Transplant Suitability Index) scoring of restoration area; color-shaded areas near shoreline indicate a non-zero score and potential planting sites.

A significant amount of work was done on refining the preliminary transplant suitability index (PTSI). PTSI model output and the resulting map effectively focused the search for suitable sites, thus reducing the number of areas targeted for further investigation. Sites that scored well on the PTSI index (preliminary transplant suitability index) received "groundtruthing." As a result, large areas of potentially suitable bottom that had shown up on the original site selection map were eliminated due to subsequent field observations and testing (Figure 4).

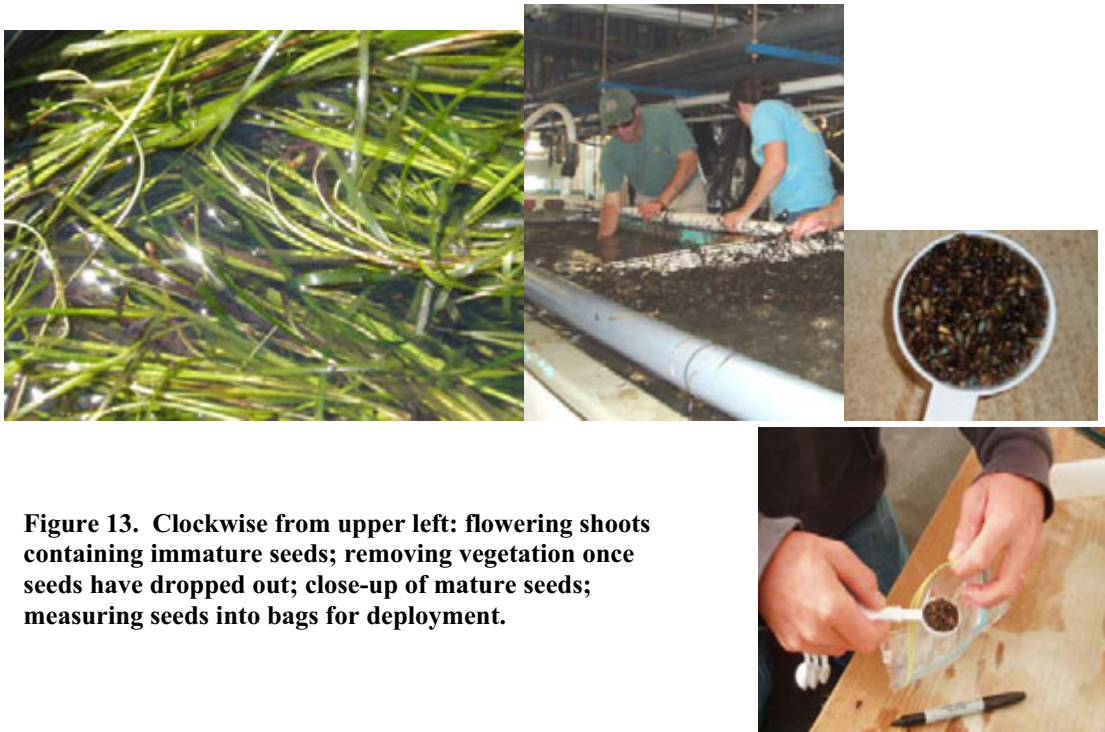
Figure 13. Clockwise from upper left: flowering shoots containing immature seeds; removing vegetation once seeds have dropped out; close-up of mature seeds; measuring seeds into bags for deployment.

Twelve fish totes of flowering shoots were harvested from Nahant in July. The shoots were delivered to flow-through seawater tanks at the Marine Biological Laboratory in Woods Hole. They remained there for approximately six weeks until seeds ripened and dropped out of the leaves. Thereafter, vegetation was discarded and seeds were collected and sorted from detritus using a series of sieves (Figure 13).

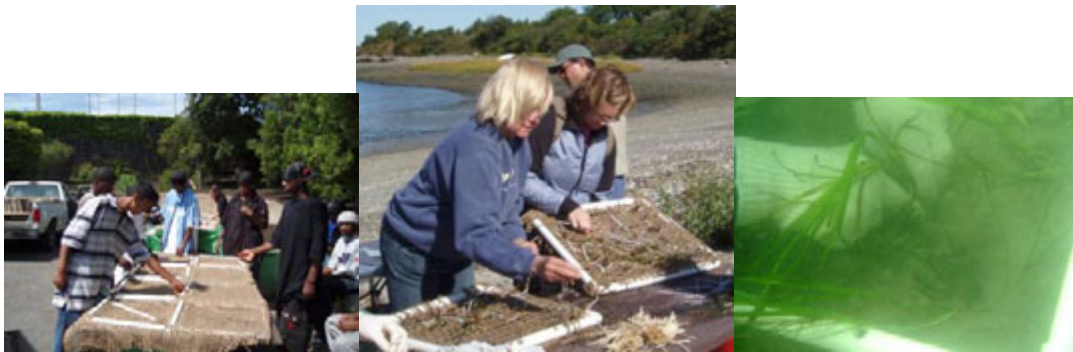
Figure 15. Volunteers building PVC/jute frames (left), tying eelgrass shoots to PVC frames (middle) and diver hand-planting eelgrass (right).
